RCRA FACILITY ASSESSMENT
OF THE
E.I. DUPONT DENEMOURS AND COMPANY, INC.
CHESTNUT RUN PLAZA
WILMINGTON, DELAWARE

EPA ID NO. DED003930799

Submitted to U.S. EPA - Region III
September 20, 1991

RCRA FACILITY ASSESSMENT REPORT
E.I. DUPONT DENEMOURS AND COMPANY, INC.
CHESTNUT RUN PLAZA

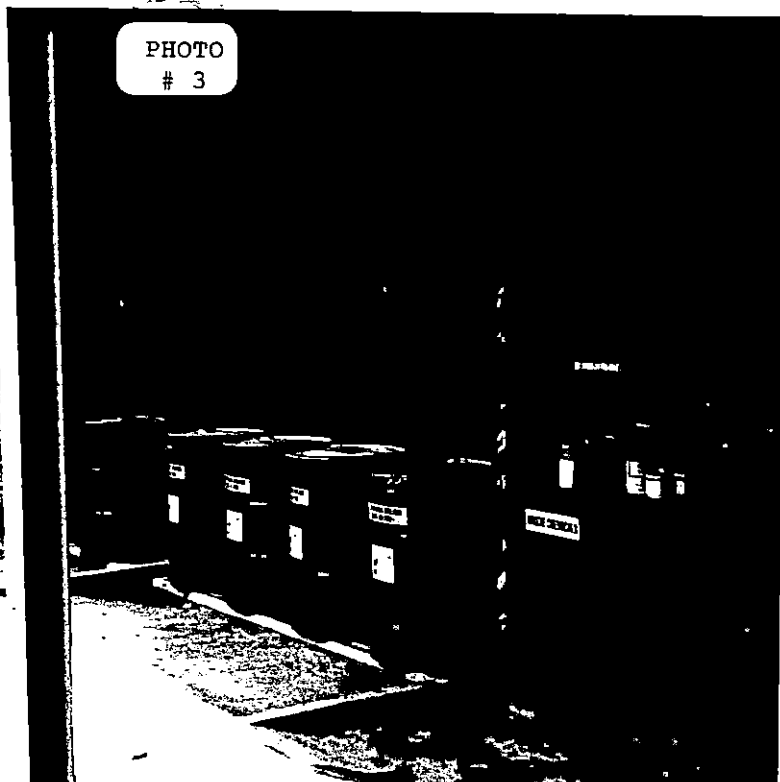
PHOTO
3

Unit Description: This chemical storage area, located within the west wing of Building 702, has been in service since 1977. It stores and distributes the small quantities of lab chemicals used by the Fibers and Composites Development Center (FCDC), Buildings 701 and 702. Additionally, this area is used for the accumulation of various non-regulated solids (carpet fibers, textile swaths, and scrap Kevlar) and waste oils. Old lab chemicals are repackaged for disposal in lab-packs in this area, and are disposed directly from this location. No hazardous wastes are stored in this area, since these chemicals are not classified as wastes until placed in the lab packs (i.e.: discarded).

PHOTO #3 - SWMU #3

Non-Hazardous Waste Storage Area - Building 702

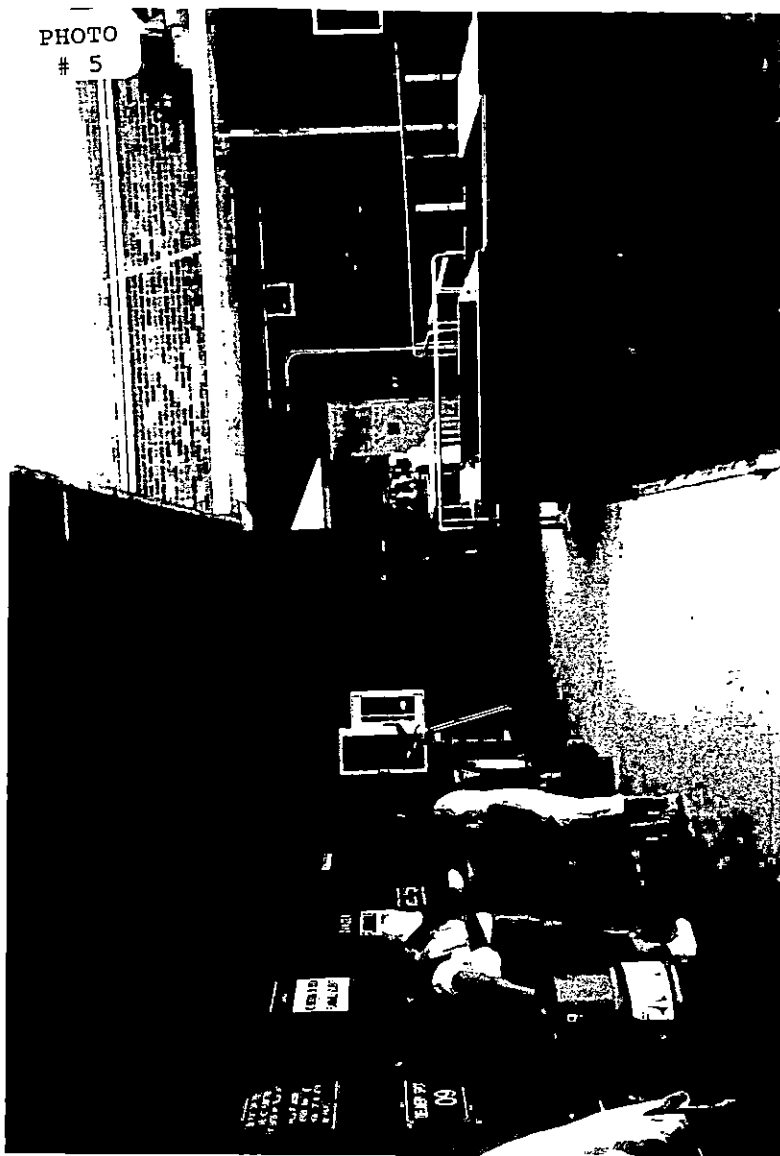
PHOTO
5

Unit Description: The loading dock off Building 709, primarily used for receiving and shipping, has a small area that is used for 90-day hazardous waste accumulation, as well as solvent storage and disbursal. The dock consists of a concrete deck elevated 4 feet above the surface of the driveway, and is covered by a metal roof. There are no floor drains in the area.

PHOTO #5 - SWMU#5 &
25

90 day Hazardous Waste Accumulation
Area - Building 709

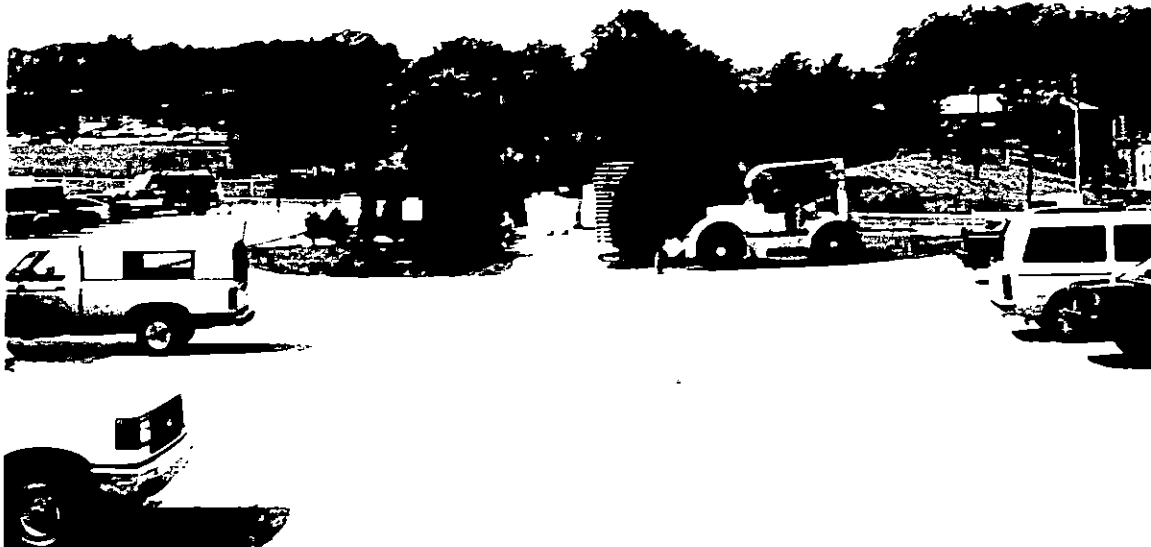
PHOTO
6

Unit Description: This storage pad, located 100 feet from Building 709 loading dock, is a 20' by 30' concrete pad, built in the 1970's as a test pad for a concrete study. In 1988, it was replaced. It is now used to store clean test equipment used in mill trials at various customer locations. This equipment is cleaned at the customer's site before storage at Building 709. In addition, when the Chemicals Department at Building 709 has filled a drum at their 90-day hazardous waste accumulation area (SWMU #5), they move the drum over to this concrete pad for temporary storage, prior to shipment to the site permitted storage pad. In the past, the pad stored waste ethyl acetate for very short periods of time. Additionally, the pad was once used in 1985 to repackage drums.

PHOTO #6 - SWMU #6

Temporary Waste Storage Pad
SWMU # 6
Alan Simpson

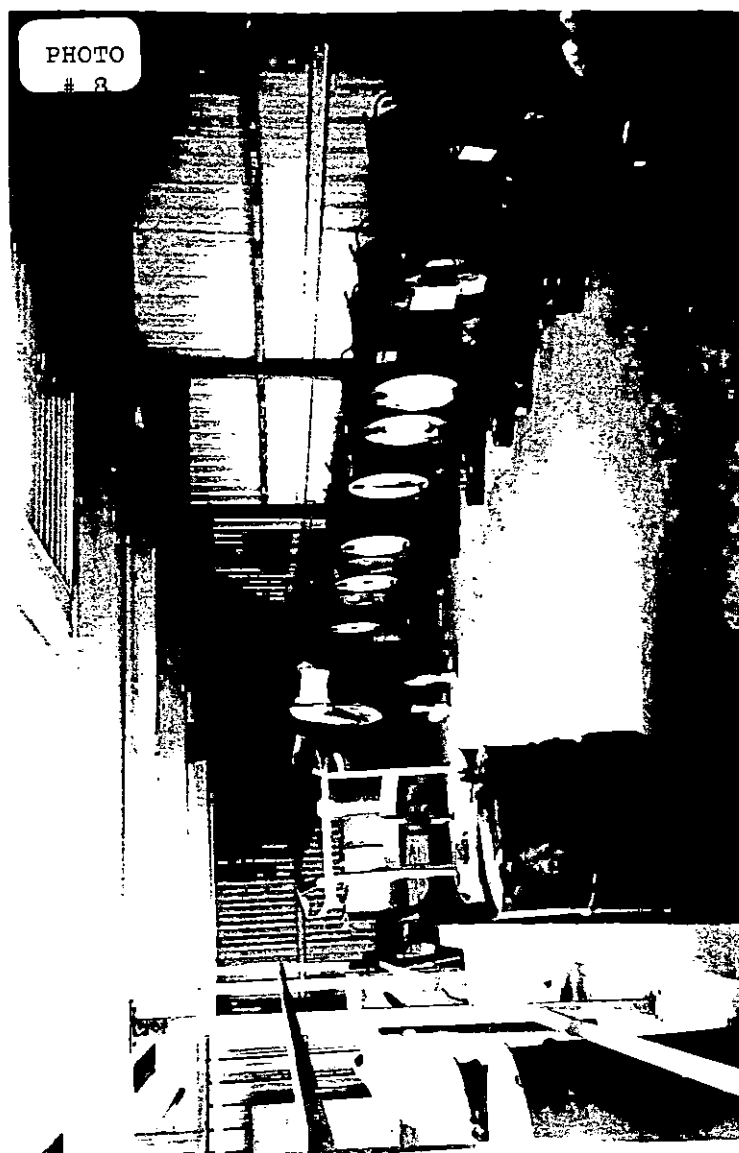
PHOTO
8

History of Release: On the day of the VSI, a small amount of liquid was located within the concrete sump. The liquid seemed to have a sweet smell, no readings were observed on the Photo Ionization Detector. Some staining was evident on the collection system gate.

PHOTO #8 - SWMU #7

Due to the presence of standing liquid located in the secondary containment sump, the facility should verify the integrity of the unit. If the integrity of the sump has been impaired, soil sampling may be warranted to determine if hazardous constituents have been released. Soil samples should be obtained from these areas where the unit is impaired. The analytical parameters of concern include priority pollutant metals, priority pollutant volatiles, semi-volatiles/AB & N Extractable Compounds and Total Petroleum Hydrocarbons (TPH). Based on the results, ground water monitoring may be warranted.

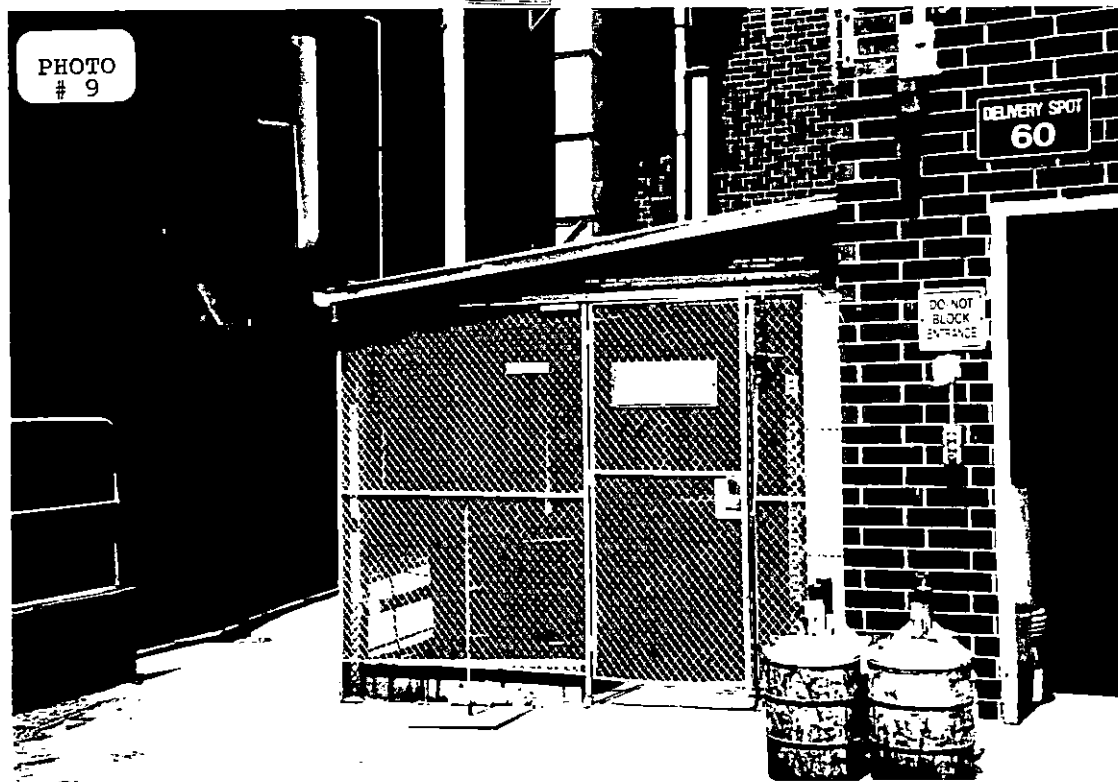
PHOTO
9

Unit Description: This 90-day waste accumulation area, located at the southwest corner of building 711, is a concrete pad used for raw solvent storage and hazardous waste accumulation. The pad is 25' by 10', and is enclosed in a metal mesh fence on three sides and the brick wall of the building on the fourth side. The pad has a fiberglass roof and a concrete floor that slopes to an 8" containment dike. The dike has a plugged drain. Once manually unplugged it drains into the sewer system.

90-day Hazardous Waste Accumulation Area
Building 711 F

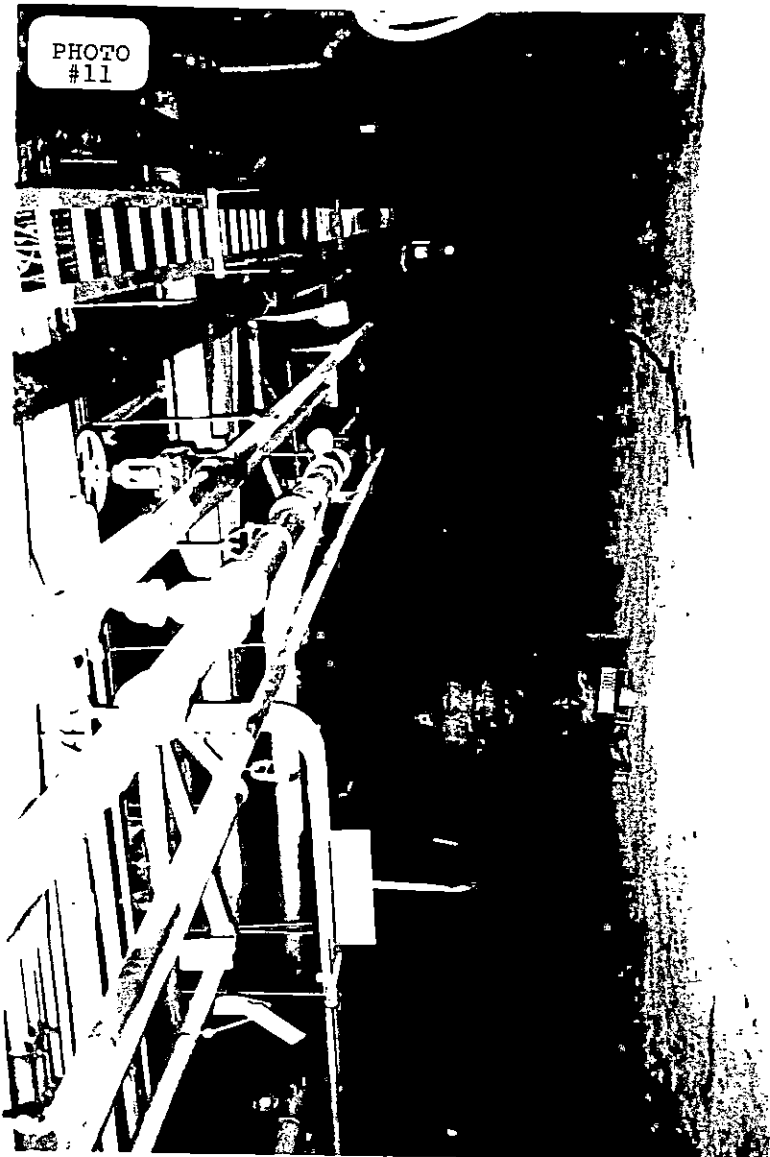
History of Release: The oil from leaking overhead milling machinery from 1955 to present. A soil investigation conducted in February 1991 revealed localized areas of soil discoloration to a maximum depth of 5 feet in the crawlpace. Chestnut Run initiated soil sampling and the results of this analysis show Total Petroleum Hydrocarbon (TPH) contamination as high as 38,000 ppm. Chestnut Run has begun additional investigation (4 soil borings around the building perimeter) to determine if the oil has migrated.

PHOTO #11 - SWMU #9

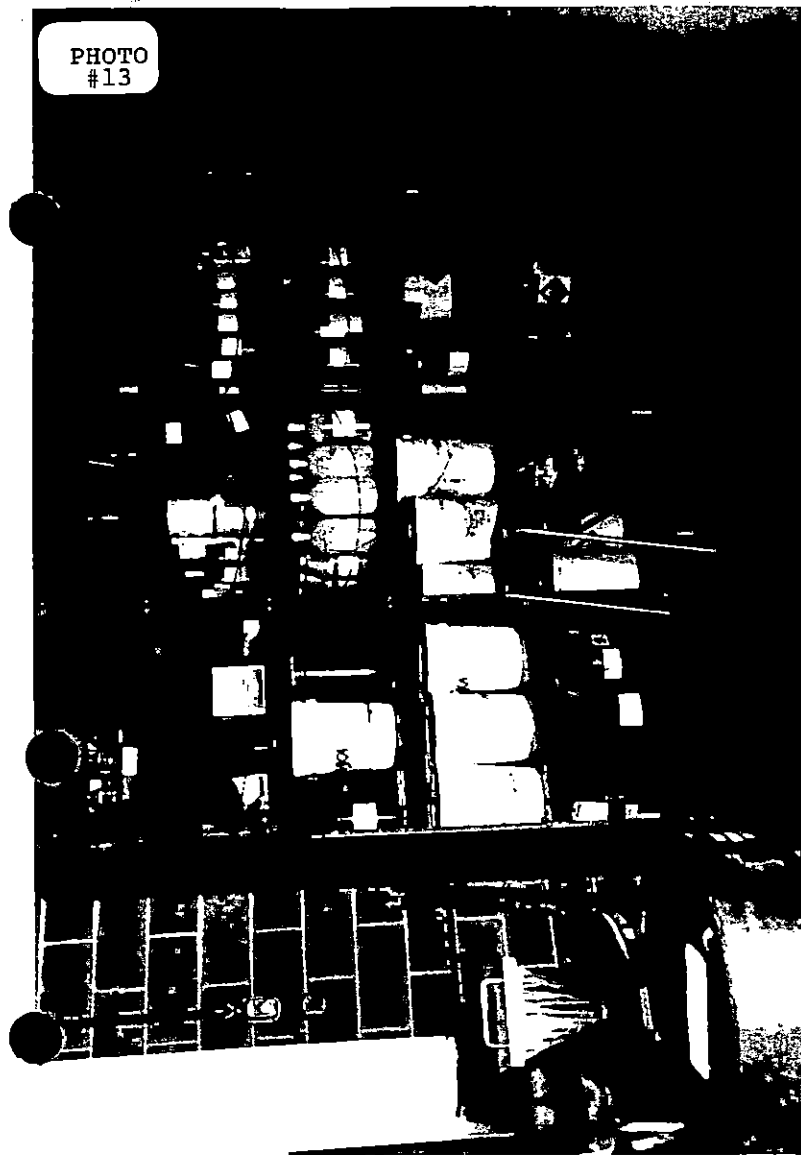
Unit Description: This area, located inside Building 712, has been used for 15 years as a storage facility for virgin and waste solvent storage. The unit is a 9' x 12' enclosed storage room within Building 712, designed to store flammable liquids and waste solvents. It is on the site's 90-day hazardous waste accumulation areas.

PHOTO #13 - SWMU #10

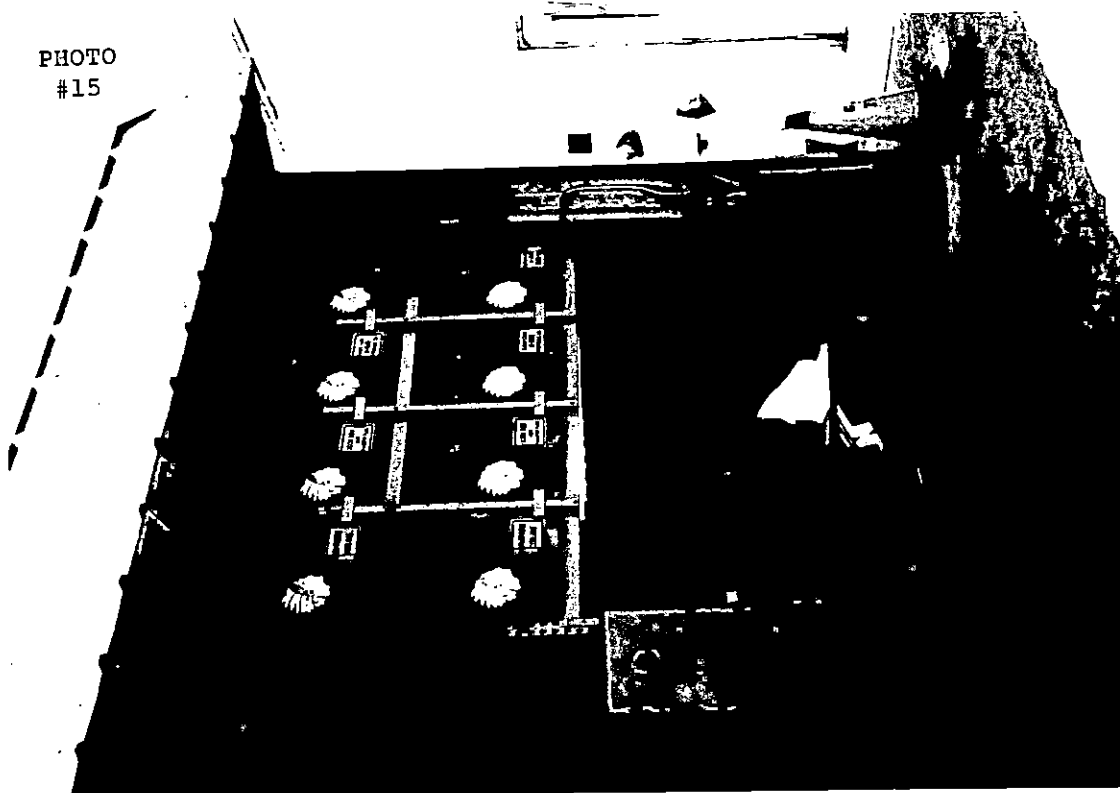
Unit Description: A 28' by 5' section of the loading dock of Building 713 serves as an accumulation area for non-hazardous waste oil and raw chemical storage associated with the thermoplastics molding, extruding and testing activities. The area, protected on three sides by metal walls and is covered by a metal roof. The concrete floor of the loading dock is raised about 4' above the level of the paved truck unloading area. Behind the storage area there is a concrete gutter for stormwater run-off, which slopes down to the level of the pavement and adds further protection to the adjacent soil.

PHOTO #15 - SWMU #11

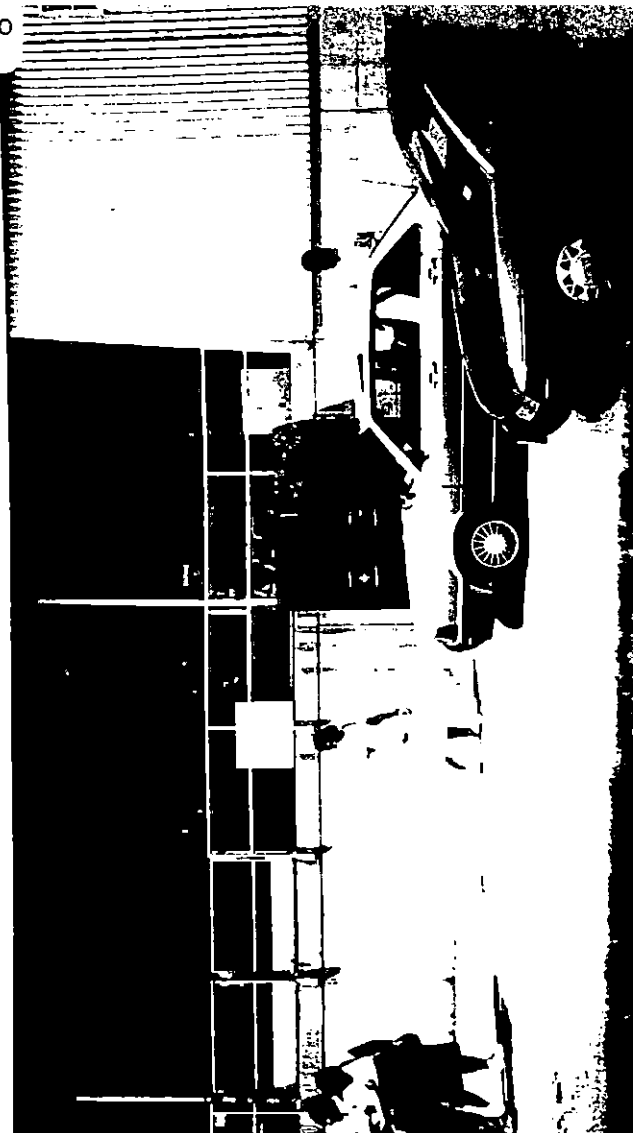
Unit Description: The Electronics Department maintained a 90-day hazardous waste accumulation area on the loading dock off of the plating area and raw chemical storage shed. This loading dock area has a concrete floor and a roof. Wastes managed include halogenated solvents used in electronics etching operations, and other waste chemicals used in etching and plating operations such as copper, sodium hydroxide, formaldehyde, sulfuric acid, thiourea, sodium persulfate, n-butylethanol etc. In addition, filtrate from the solvent filtration process was stored in this area including filtrate 1,1,1 trichloroethane and methylene chloride. Annual quantities of wastes managed are approximately 7000 gallons of mixed aqueous including acidic, alkaline, organic and approximately 600 gallons of halogenated solvents.

PHOTO #17 - SWMU #13

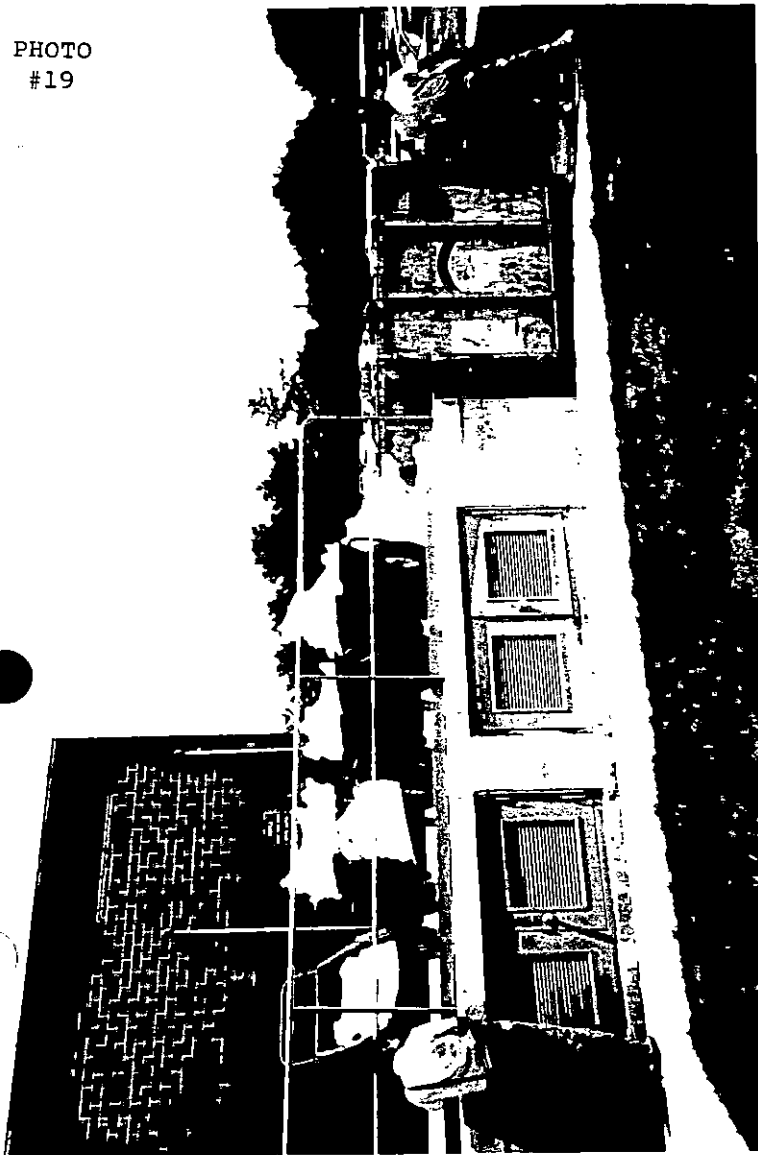
PHOTO #19 - SWMU #15

Polyester Resin Cooling Dock &
Refuse Dumpster

The facility should consider covering the dumpster with a tarp to impede storm water infiltration. No further action is suggested, under RCRA, at this time.

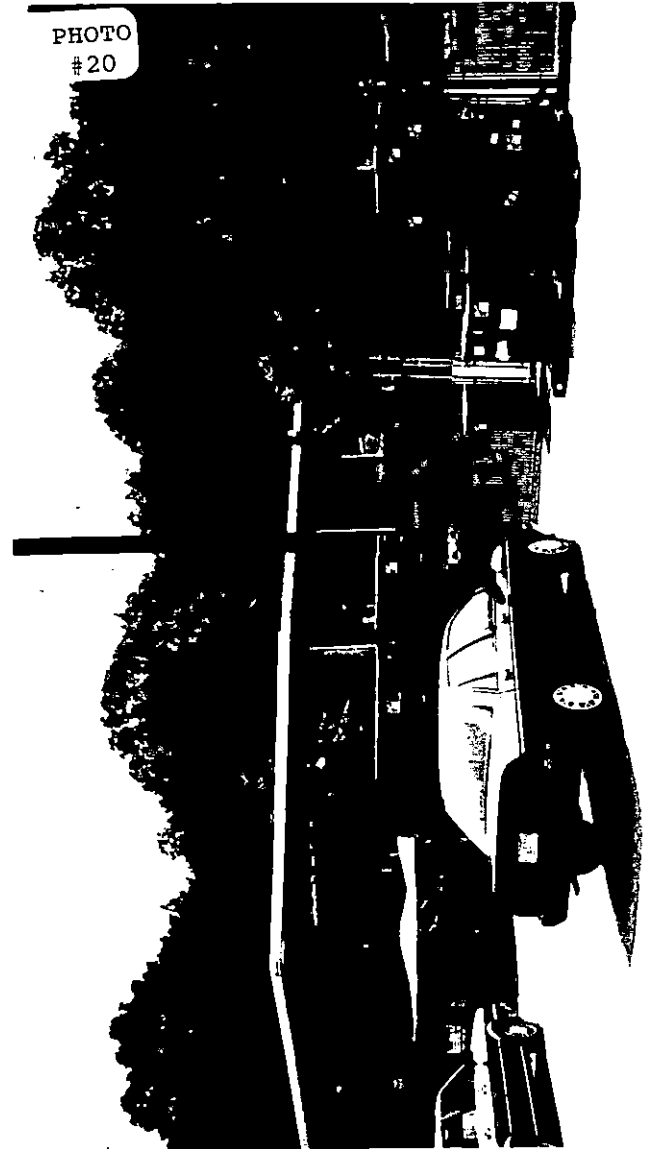
Unit Description: Non-hazardous, solid waste is temporarily stored in the asphalted area adjacent to the permitted storage pad and scrap metal area, behind Building 718. It is the area outside the fenced scrap metal area. All waste material is containerized before it is stored at this location, and the vast majority of the non-hazardous waste is Teflon from the Polymers Department. This area has been used for solid waste management since the 1960's.

PHOTO #20 - SWMU #16

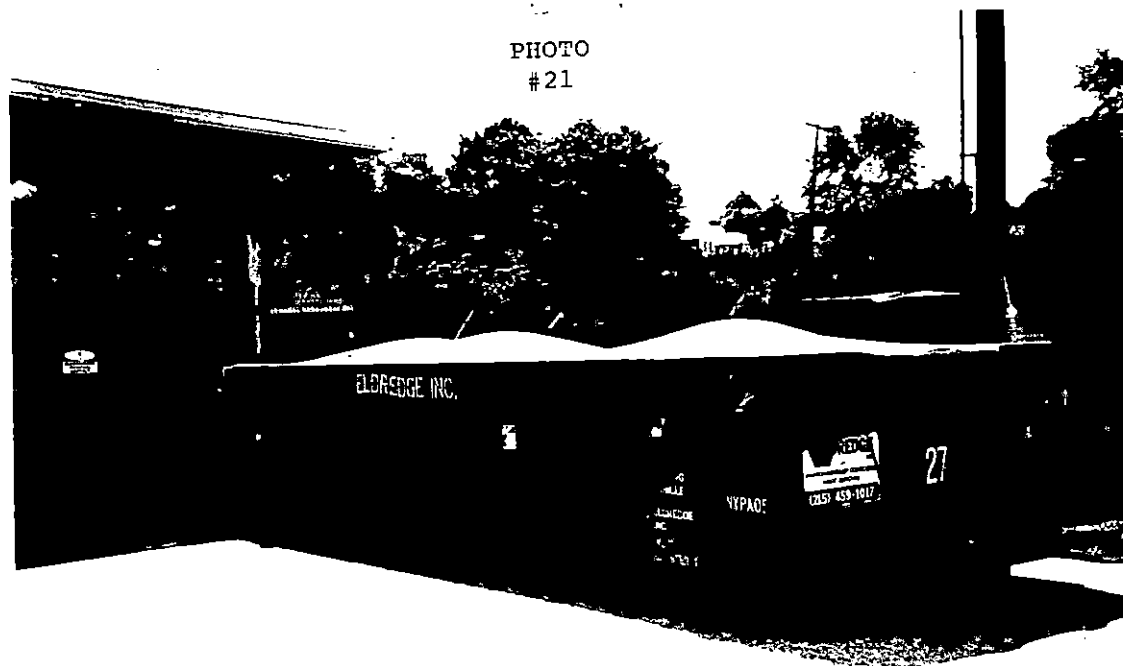
PHOTO #21 - SWMU #16

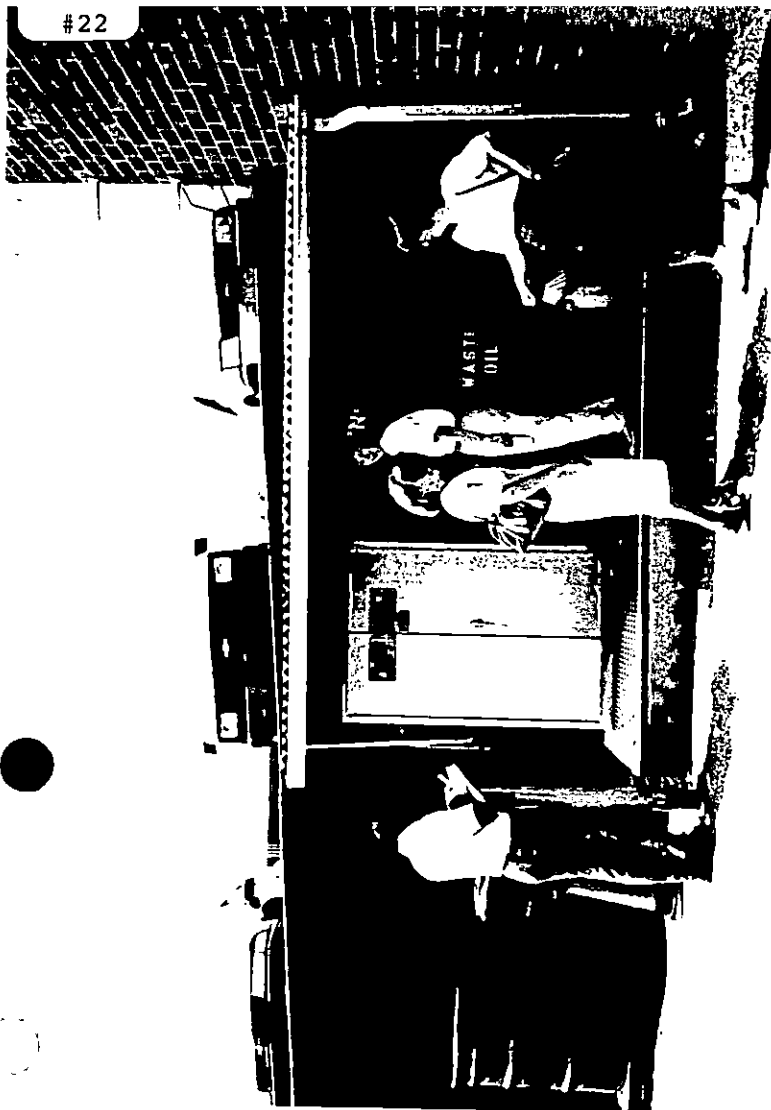
Unit Description: This satellite accumulation area is located behind building 717 which serves as a site maintenance shop. Activities include maintenance, fabrication, repair of equipment and machinery, welding, and sheet metal milling.

PHOTO #22 - SWMU #17

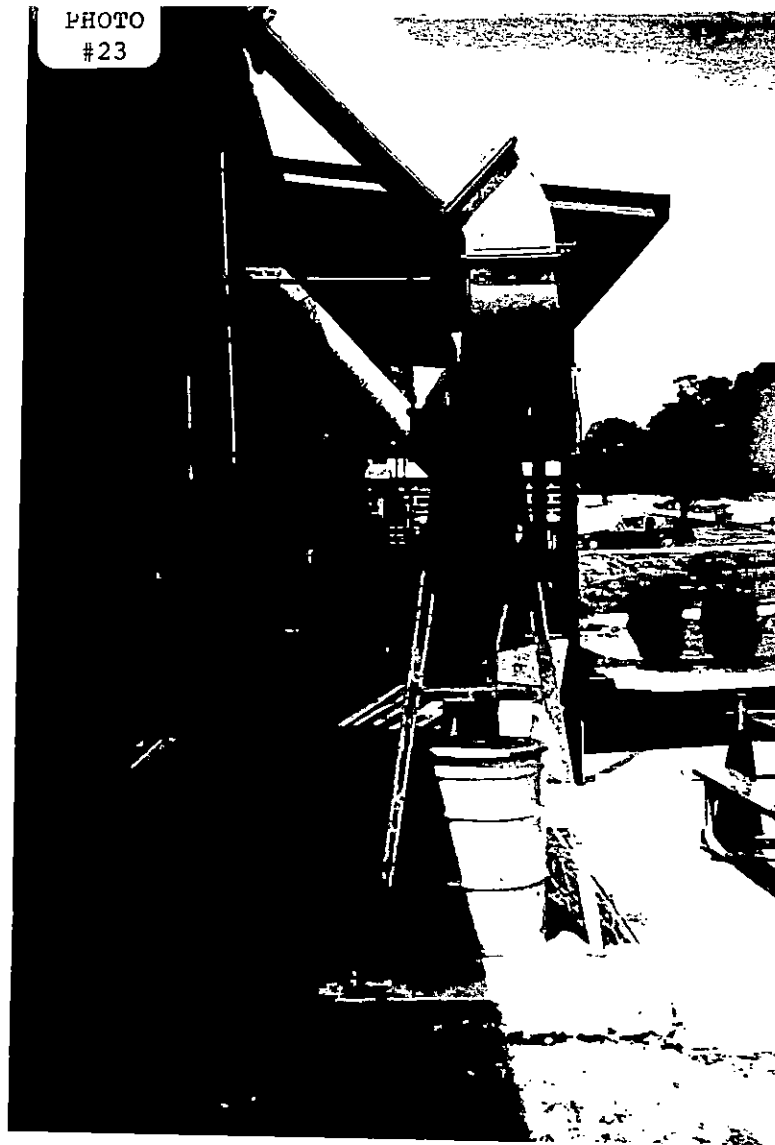
PHOTO #23 - SWMU #18

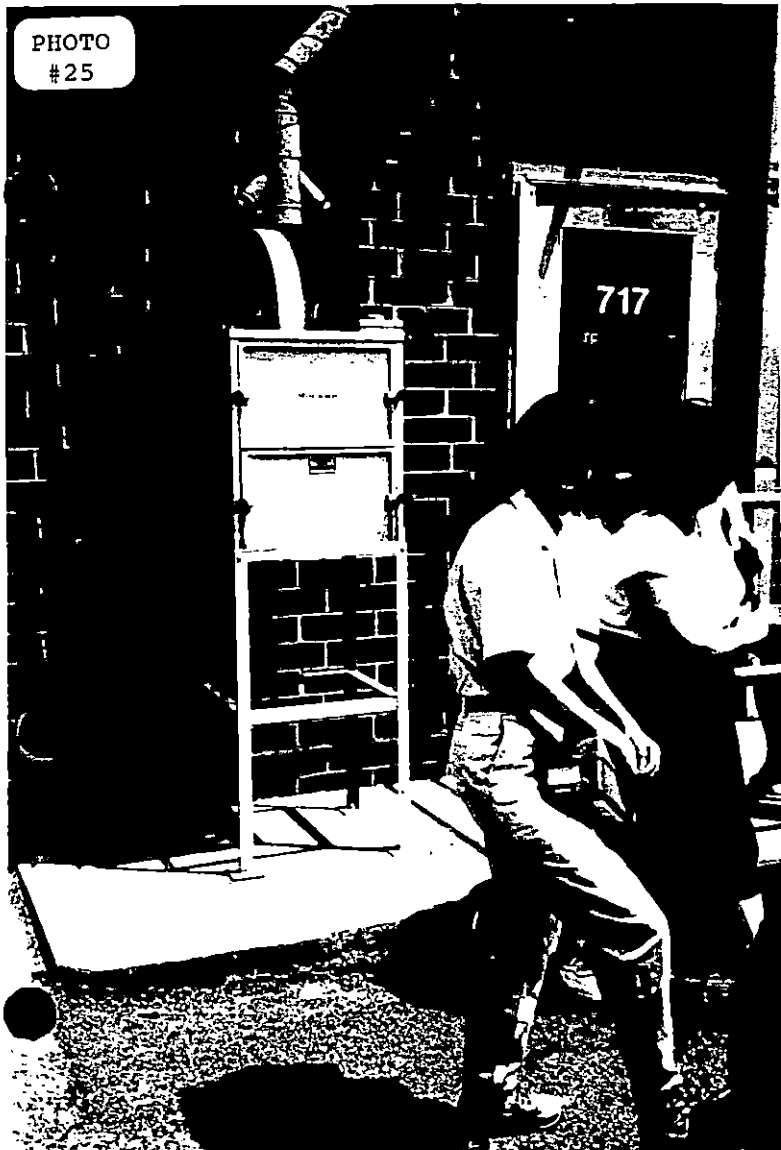
PHOTO #25 - SWMU #18

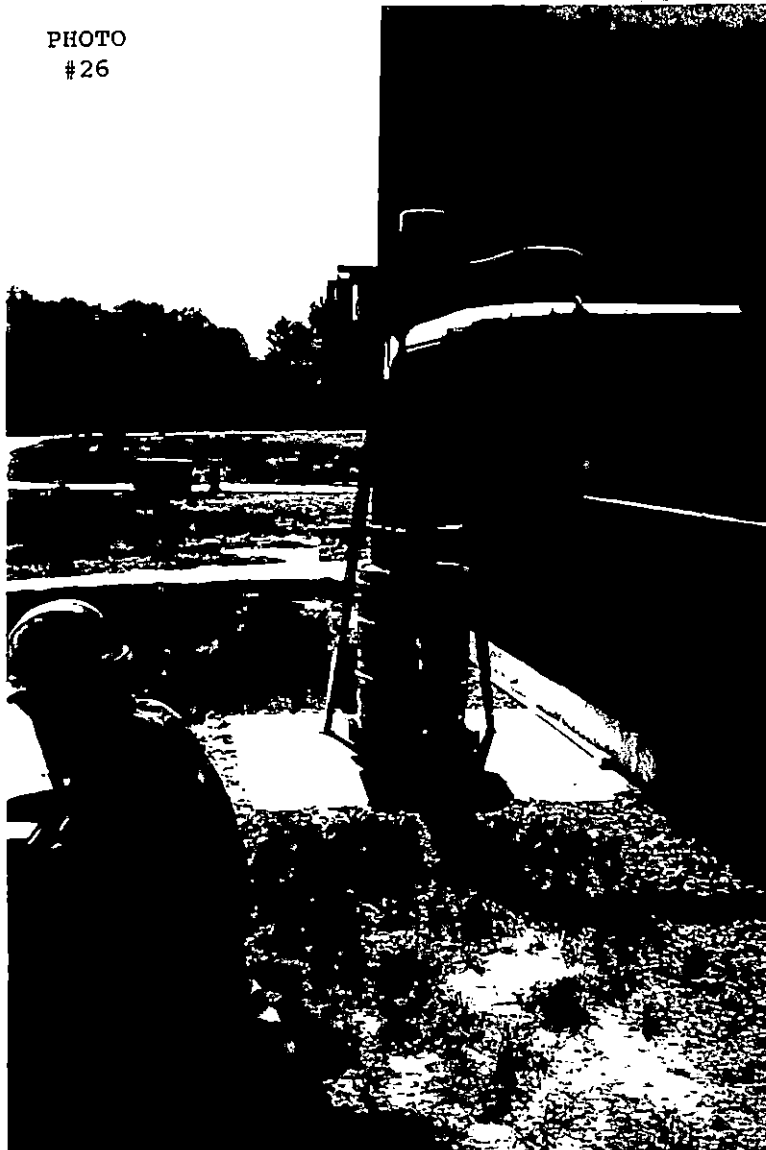
PHOTO #26 - SWMU #18

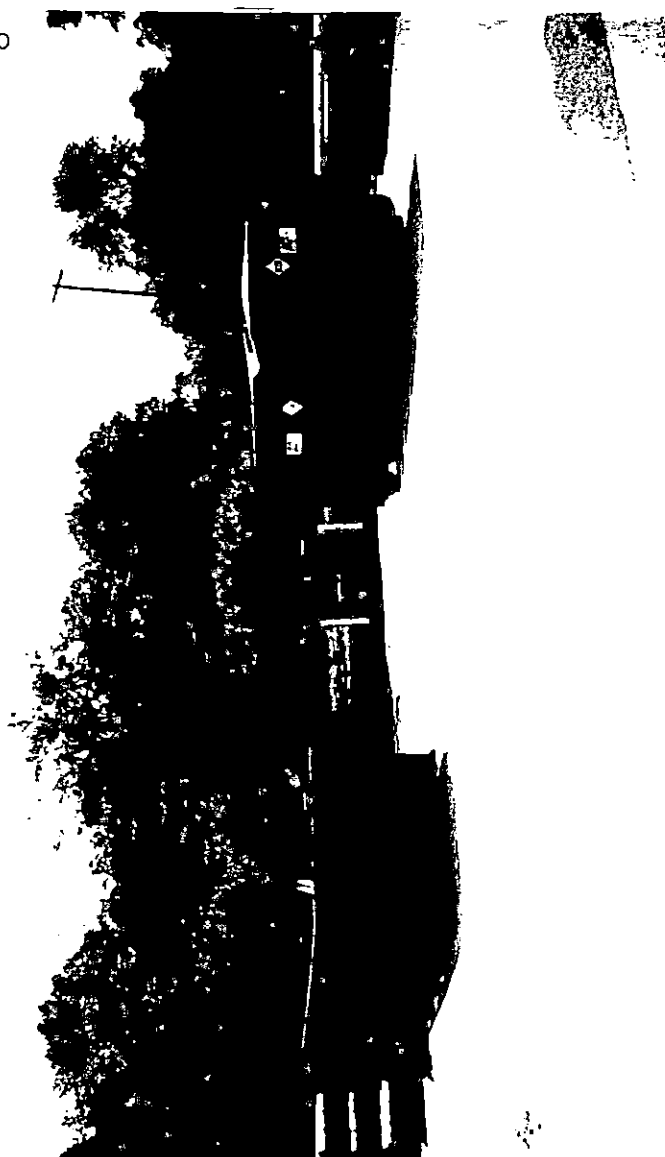
PHOTO #32 - SWMU #23
& 24

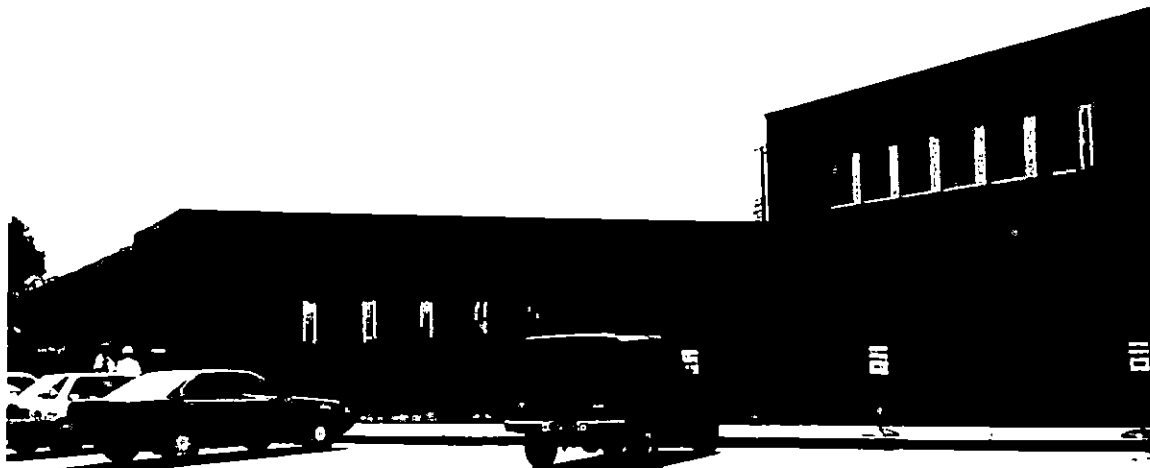
PHOTO #39 - AOC #3

Aluminum Can/Plastic Bottle Recycling Bins
